July 8, 2004

Site Inspection, Kennecott Barneys Canyon Mining, Barneys

Canyon Mine, M/035/009, Salt Lake County, Utah

June 25, 2004

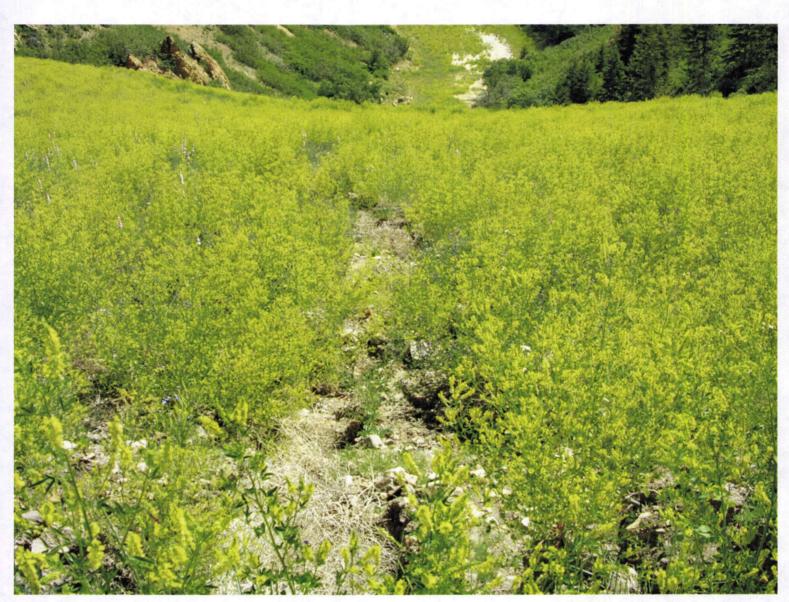
There is one problem area on the face of the dump near an area which has an area which has a fairly deep rill running $\sim \! 100$ feet down the slope. After a closer examination of the rill, it was determined that this area had washed out before the establishment of the vegetation. This is evidenced by the fact that, at the time of our visit, there was vegetation growing in the bottom of the rill. Kennecott was advised to monitor this area to determine if this rill was the result of a spring storm event or an ongoing problem which would need to be corrected. The cause of the rill will dictate the remedy to the problem.

Dump RILL

It's recommended that the vegetation continue to be monitored at the site and any marginal areas be reseeded. Also continue to monitor the reclaimed areas for areas that may become affected by runoff.

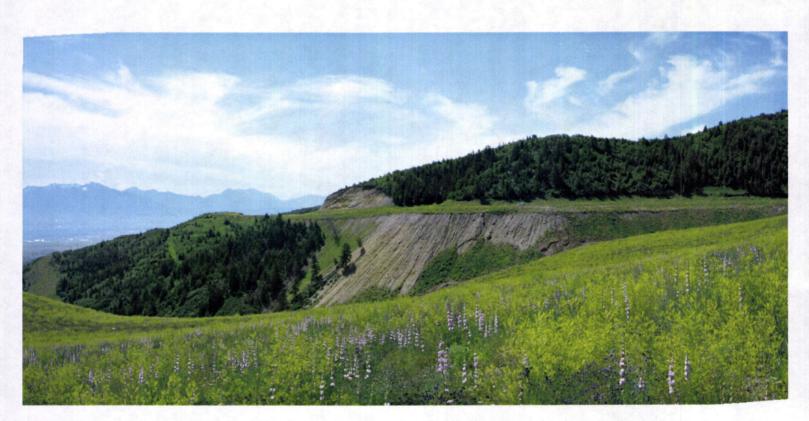
There was also an outslope area of the haulroad immediately above this area where the vegetation has not become established. This is an area where, because of the location, the slope could not be reduced. Soil was cascaded over this area but in a portion of this slope the soils did not stay on the slope. The soil remained on areas on either side of this area and the vegetation is becoming established. It's believed that this area will fill over time. If the soil would not stay on the first effort, it's believed that the results would be the same if it were attempted again. A picture of this area was taken and is included with this report.

HAULROAD OUTSLOPE
